B & R Engineering ca 3700
Structural and Inspection Specialist
(405) 755-8894 (405) 317-2478

RE: Engineers Report
1427 Edna Ln.
Woodville, Oklahoma

Structural Inspection
Dr. Bob Watson P.E.
Date: 5-30-06

PLAN VIEW OF HOUSE PERIMETER

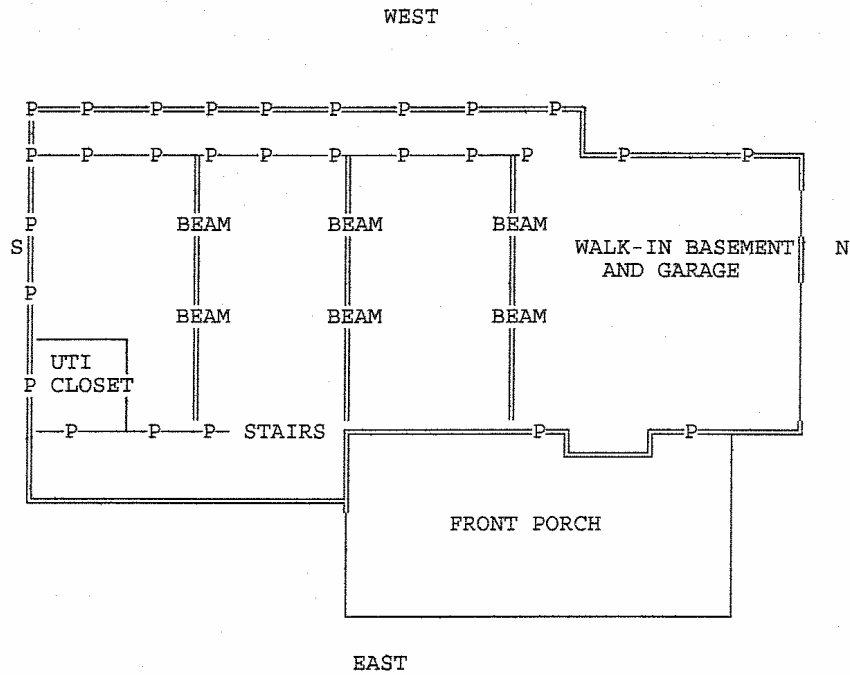
P = Approximate location of Eleven (11) perimeter steel piers and seventeen (17) inside piers recommended.

It is B & R Engineering's opinion from our visual investigation and evidence obtained, that a total of twenty-eight (28) steel piers are required; eleven (11) steel driven piers on the outside perimeter and seventeen (17) inside steel piers to stabilize the slab flooring and stem wall, (See page 4).

B & R Engineering recommends on the exterior perimeter that four (4) steel pier be positioned on the south exterior wall, eleven (11) steel piers on the west exterior wall, nine (9) steel piers on the inside west concrete block wall and four (4) steel pier be position on the east interior wall for stabilization. (See page four (4) for pier location.)
